Table of Contents

Matching Numbers and the DeLorean

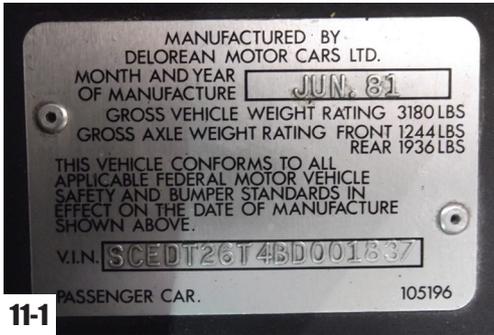
11-1

The complete Vehicle Identification Number (VIN) on a DeLorean is located in two places - the pop-riveted plate (11-1) in the driver's side door jamb about knee level, and the pop-riveted or glued plate on the dashboard (11-2).

The former almost always lists the "build month/year", though in the case of the "1983" model DeLorean cars with VINs that end in 15XXX, 16XXX and 17XXX, this build month/year is not accurate (see page 112). The build month/year may be stamped or embossed, with stamped dates more characteristic of early build cars. There is at least one known car where this area is blank, having never been stamped or embossed.

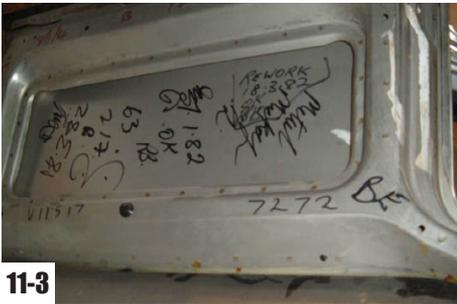
11-3

There are a couple other locations where you are likely to find at least the last five digits of the VIN, and those are on the stainless under the door headliners (11-3) typically on later, single-key cars and on the rear cross member of the frame (11-4), behind the impact absorber.

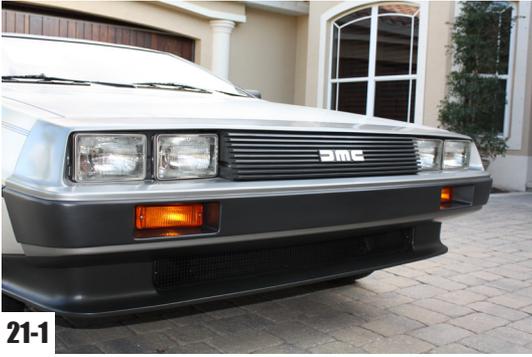
21-1

Fascias are interchangeable among all model years, but original paint finishes came in both a “glossy” (up to approximately VIN 03599) and “matte” (from approximately VIN 03600) finish (21-1). These urethane bumper covers were supplied to the factory already painted and ready to install (21-2). On original fascias the middle “bumper” area is a matte black, unpainted finish, as is the lower area nearest the bottom edge.

Grilles: The plastic grille is non-functional (21-1), and all but a few early models have a cast metal “DMC” logo (21-1) affixed in the center. Originals of both grille and logo are readily available and easily replaced.

Rock Screen: Fixed screen (21-1) beneath the front fascia that fits into the front spoiler. Original design is a mild steel wire mesh (.375 inch mesh) painted black and is prone to rust and damage from road debris. Reproduction screens are readily available.

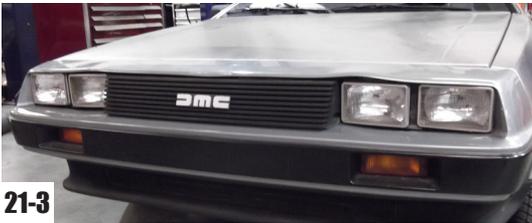
21-3

Warping over the headlights (21-3) is common, though undesirable, and can only be cured by removing the fascias, heating, straightening and reinforcing this area, and then repainting and reinstalling. Achieving an exact match when repainting has proven difficult over the years as has paint adhesion. Reproduction fiberglass front fascias are now available, unfinished, and require fitting and painting.

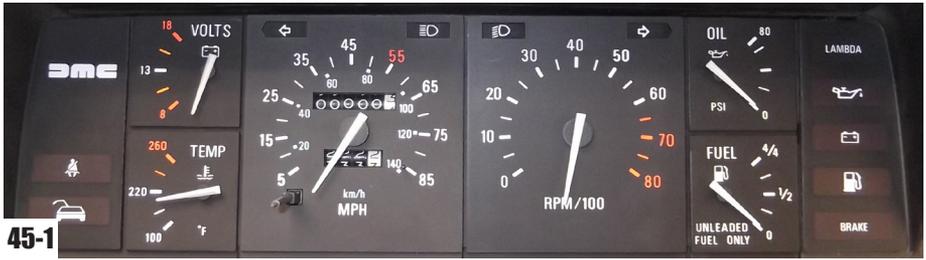
45-1

Instrument Clusters: Two different instrument clusters were used in production, one (45-1) with customary U.S. units of measure, and the other (45-2) with metric units.

Federal Motor Vehicle Safety Standards (FMVSS) at the time required that vehicles sold in the USA have speedometers that only registered up to 85 mph (in white letters, with blue subordinate metric markings) and a highlighted 55mph, the National Maximum Speed Limit at the time. The metric clusters used by the factory registered 240 km/h (in white print, with blue subordinate markings going up to 140 mph), and are believed to have been installed only on DeLoreans originally sold in Canada and the Middle East.

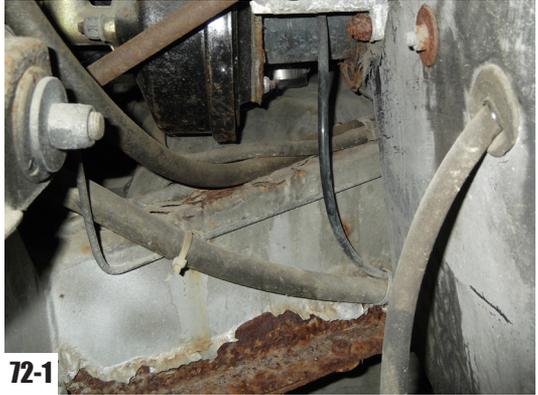
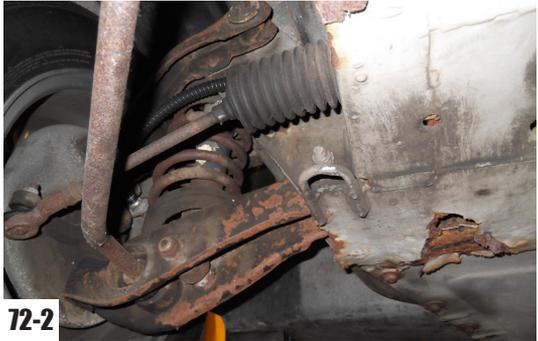
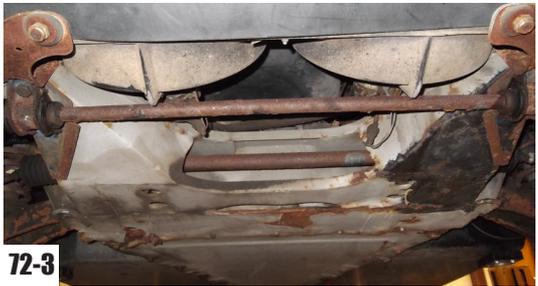
Fiberglass Underbody: It doesn't necessarily take a severe accident to have damage to the fiberglass underbody. Many times, it goes unnoticed or is sloppily repaired as it's "out of sight". Look for cracks in the visible portions, particularly in the area at the corners of the radiator and also the front and rear wheel wells. Unusual looking patches were sometimes performed at the factory to correct imperfections in otherwise good underbodies. If in doubt, get a qualified bodywork professional to examine and offer an expert opinion.

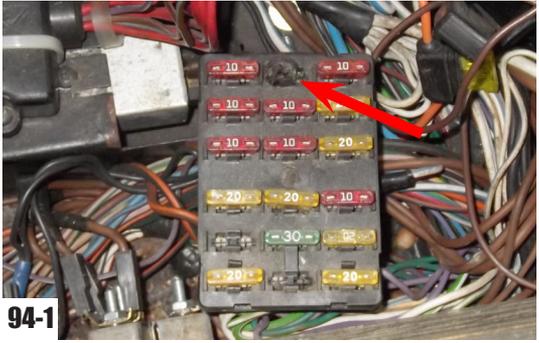
Electrical Relays/Fuses: An examination of the fusebox and relay compartment is advised. It is not uncommon that at least one of the fuses and/or fuse receptacles will be melted (94-1). This is usually the result of corrosion on the fuses and heat buildup. The installation of inline fuses is one option, though an improved reproduction fuse box is also available. The electrical relays and circuit breakers also merit attention. The original fan fail relay and cabin fan circuit breakers (see Systems) are prone to failure and some of the others are underrated or of poor quality. Relay update kits, which replace these components, are recommended for all cars that have not had these previously replaced.

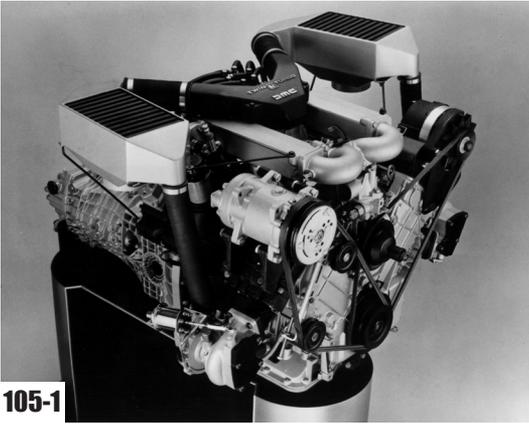
105-1

tion cars were sent to Legend and used for development and testing of both single and twin turbo (*105-1*) packages, the most famous being VIN #502. This twin turbo prototype (*105-2*) is now in a private collection in New Zealand. See page 114 for all VINs confirmed to be used by Legend.
